What I Have Learned About Lead - Part 2a Lead Balloon

Justone Lead-Soldier, 27th September 2020

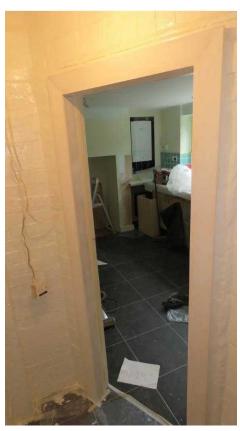
Larder

One edge of our larder door was especially vulnerable to being chipped as shown in this picture.

Our solution was to encapsulate the door frame and architrave in MDF board and paint it. This was done while the area was contained. It was also cleaned thoroughly afterwards in case any lead paint was disturbed in the process. The door hinges and stricker plates were replaced as the old ones were covered in leadpaint.
